Compliance Inspection Report: August 2019

RM File No:	RM150184
Description of Activity:	Extraction of gravel, removal of indigenous vegetation and associated earthworks
Consent Holder:	GBC Winstone Aggregates
Inspection Dates:	<u>Site inspections:</u> 24/05/19

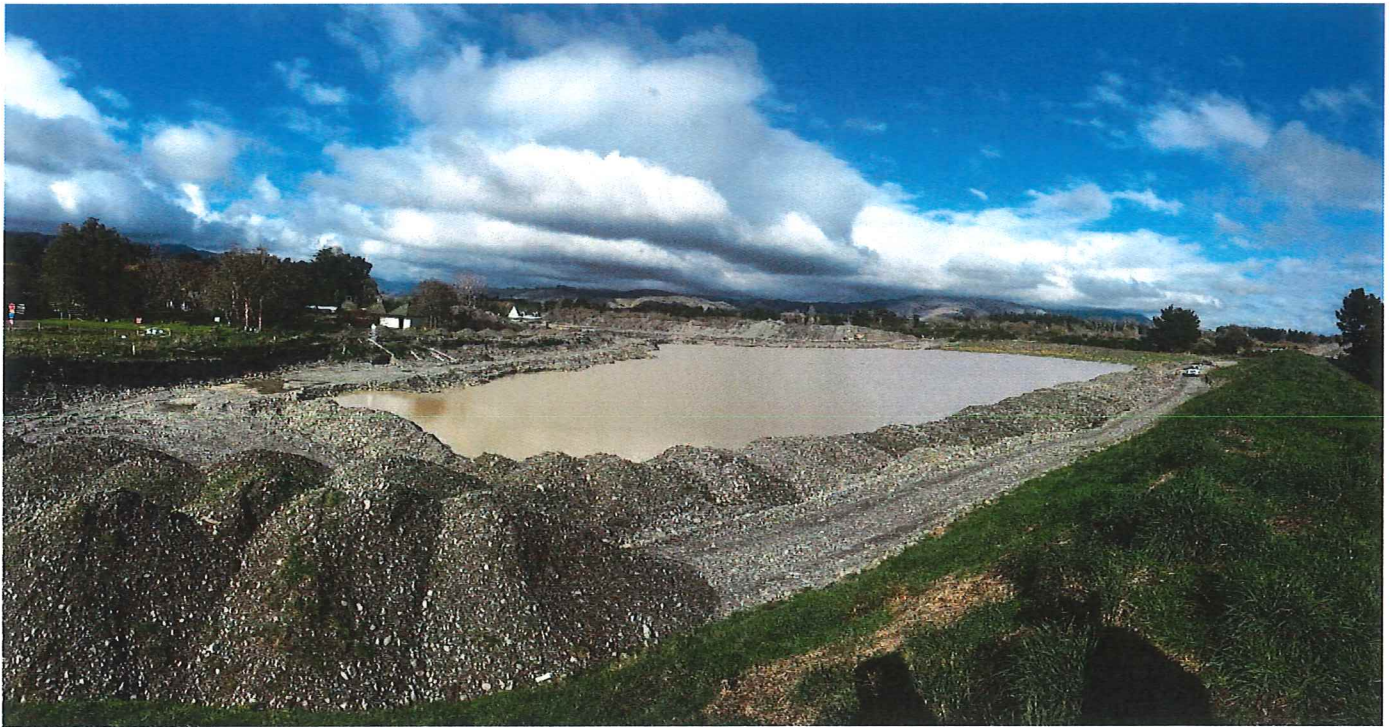
Stage 1A looking back to Stage 2 and large stockpiles in distance

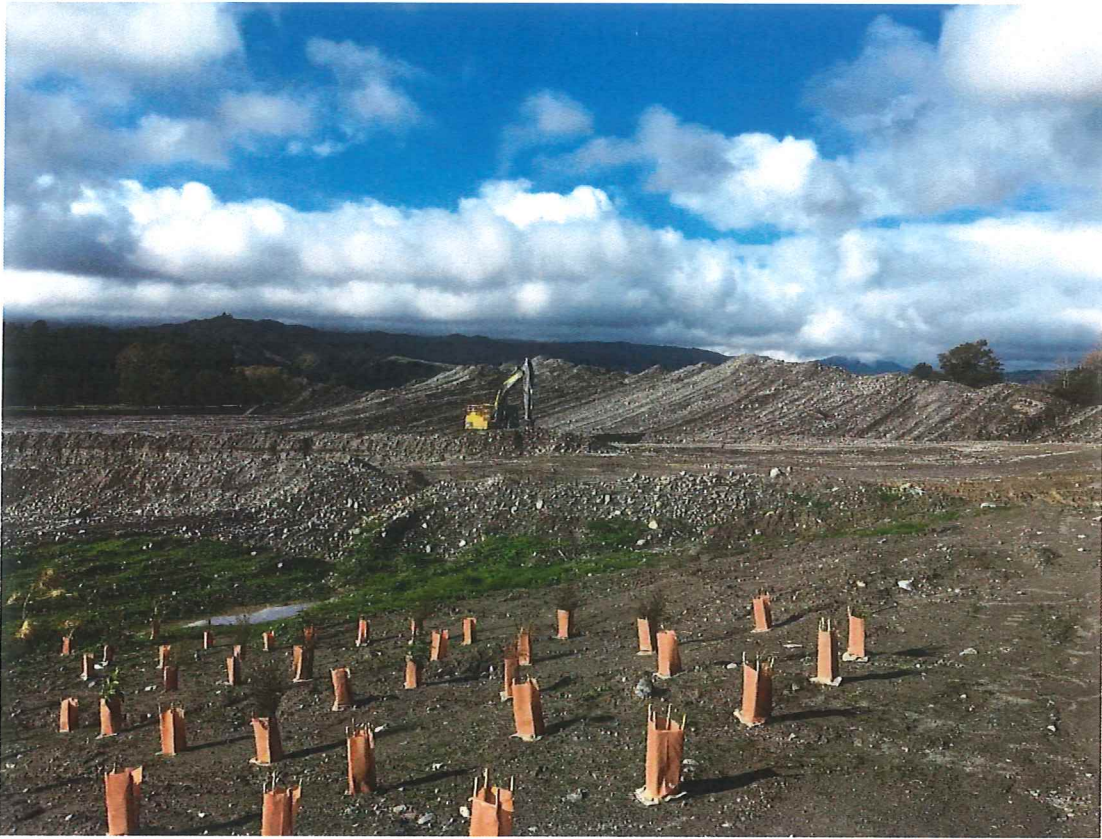
Rehabilitation plantings started in Stage 1A and Stage 2 stockpile in background

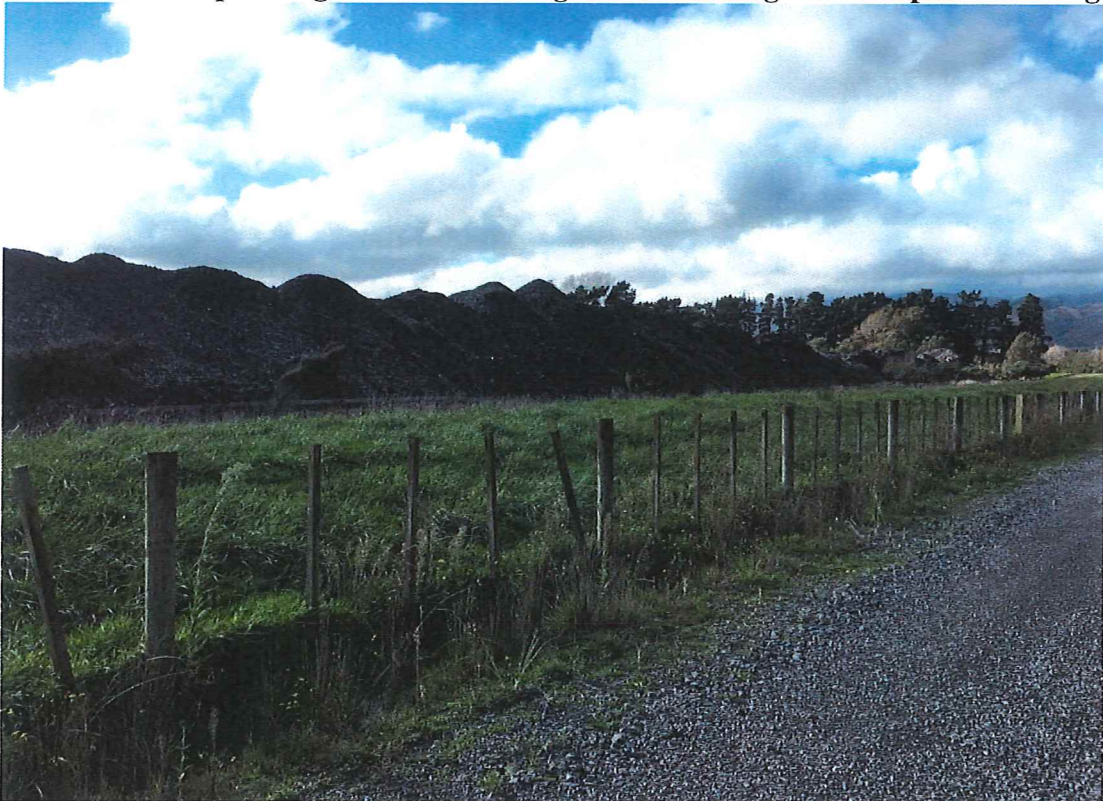
Stage 2 stockpile from river track

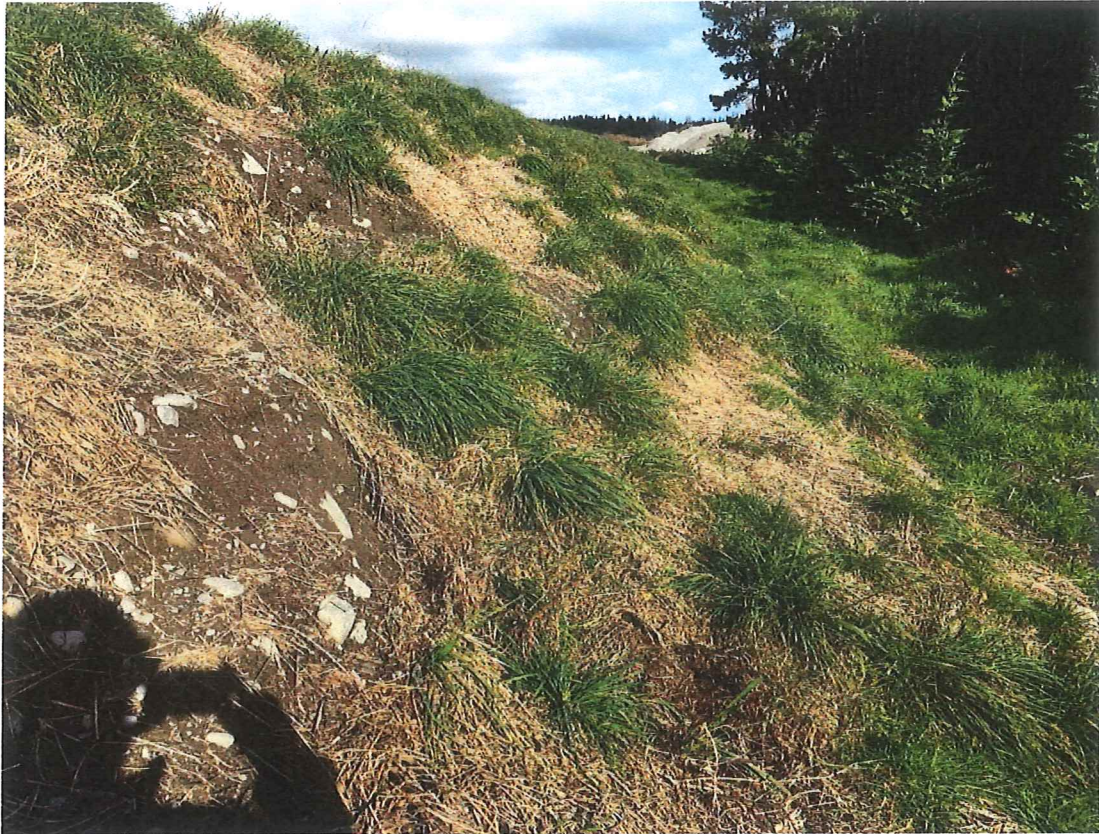
Slight movement in slump on Stage 1 bund noted.
