GBC Winstone Otaki Quarry - Silica Assessment

AECOM New Zealand Ltd (AECOM) was engaged by GBC Winstone (Winstone) to undertake a risk assessment of silica from its operations at Otaki Quarry. This letter presents observations from a site visit, a review of site dust management practices, and a silica risk assessment.

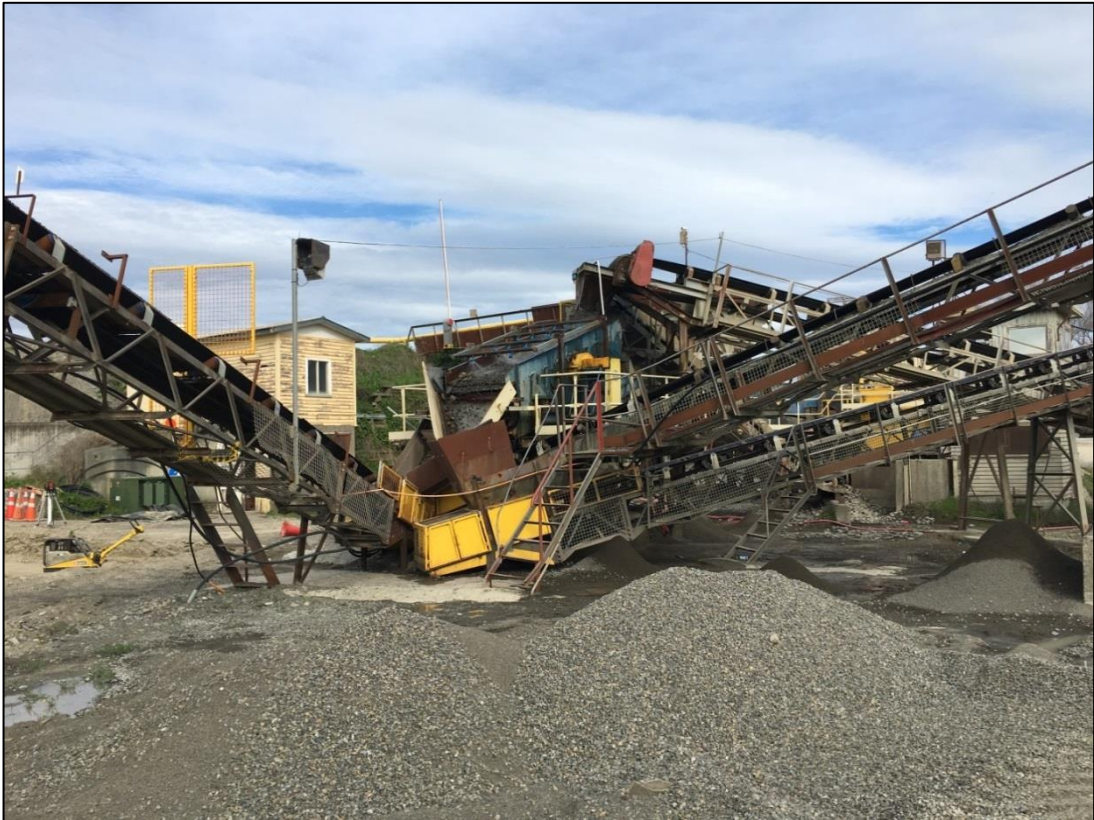
Figure 1 Crusher plant operating

Minimal dust emissions were observed from the fixed processing plant during the site visit. A water spray system was operated throughout the various screens and crushing activities, this appeared to be suppressing any potential dust emission. This is shown in Figures 1 and 2.

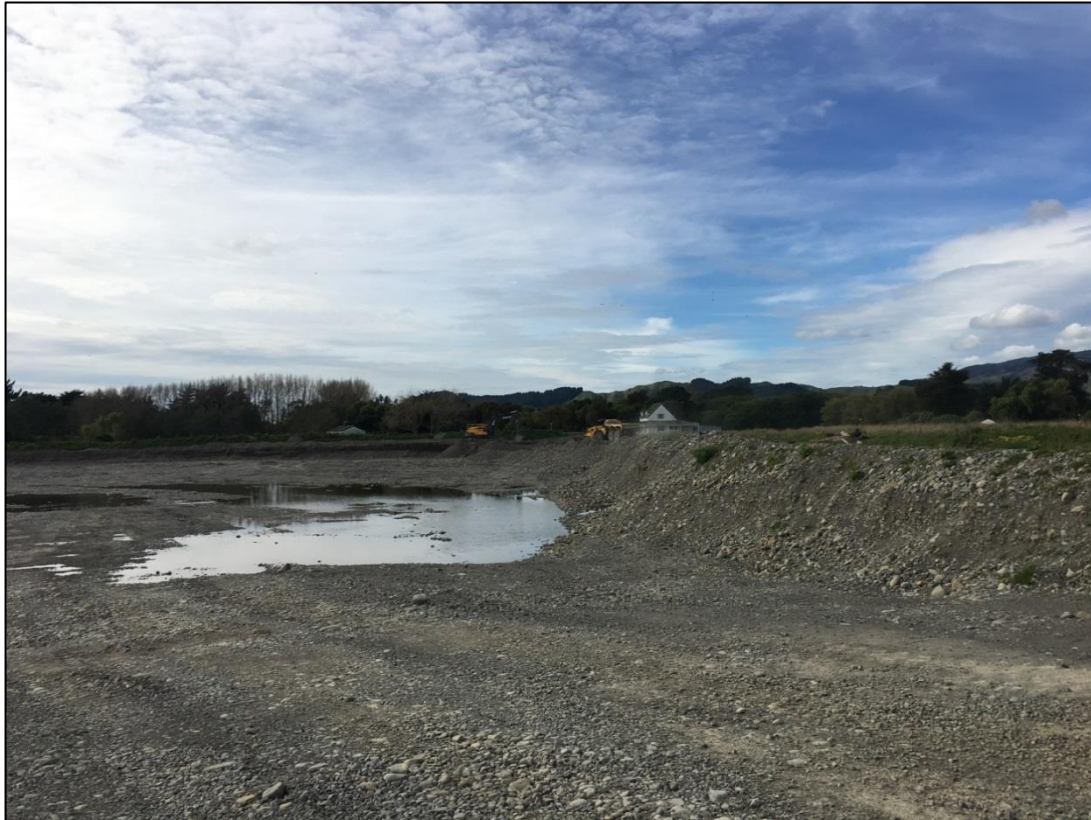
Figure 3 Ashford Park Quarry

No dust emission was observed from the extraction of material from Ashford Park Quarry. There was pooling water within the pit and the material being extracted appeared to be in a damp condition. Figure 3 shows material being extracted from Ashford Park.

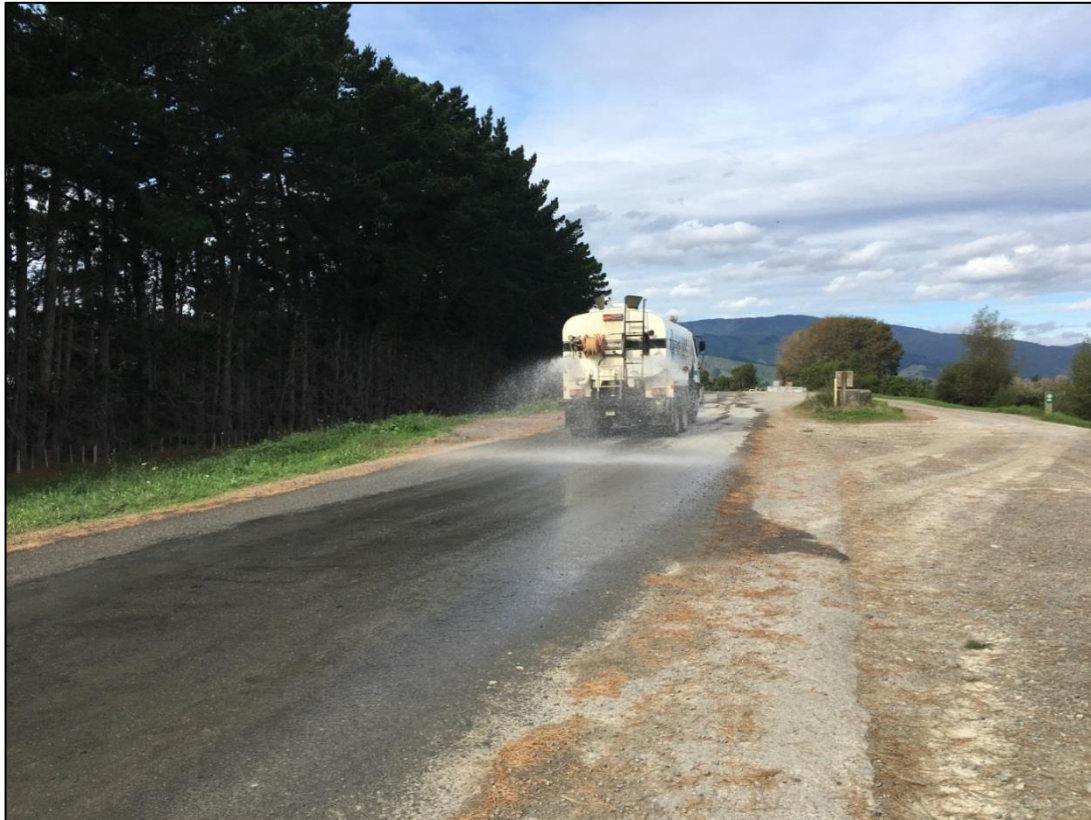
Figure 4 Water cart in operation

The haul roads were observed to be in good condition, and had recently been graded, this is usually done 1 to 2 times per month depending on the condition of the road. Generally no visible dust was observed from quarry vehicles as they travelled along the haul roads, however when a truck pulled into the shoulder of the road to allow another vehicle to get past, a small amount of dust was generated. A water cart was in operation and appeared to apply an adequate amount of water to the surface of the roads. This can be seen in Figure 4. All vehicles operating on the haul roads appeared to be complying with the site speed limit of 30 kph.

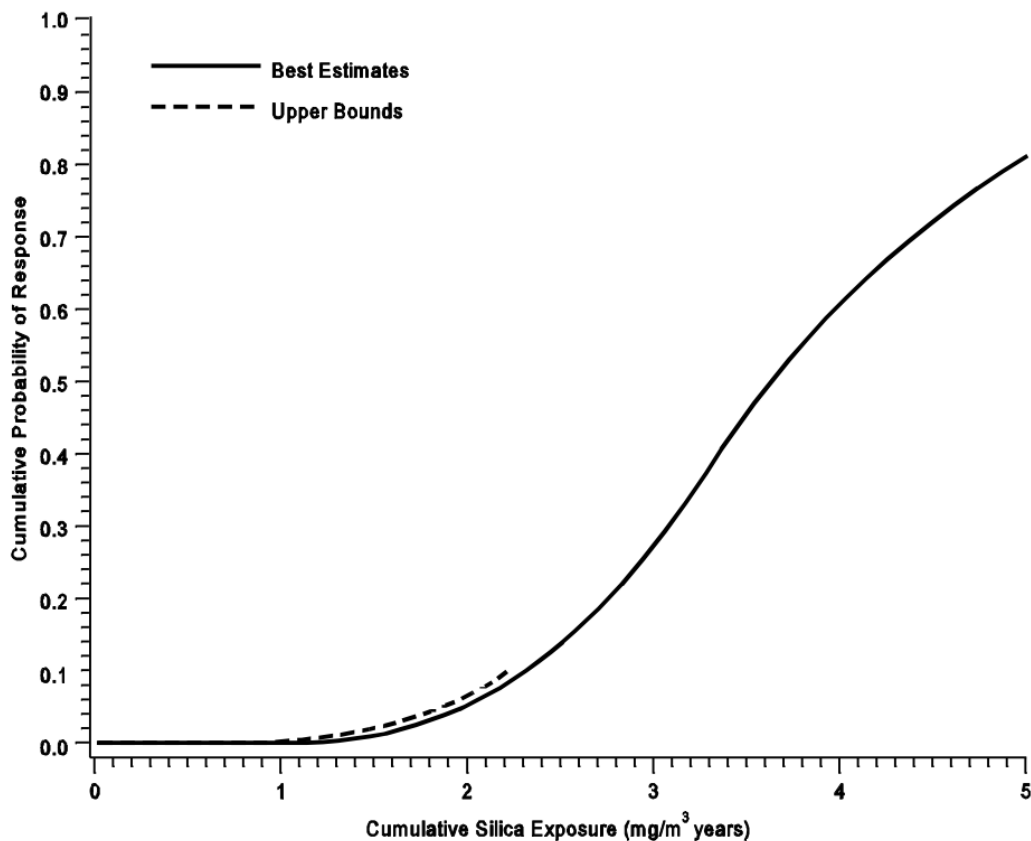
Figure 5 below presents the results of the US EPA research in terms of potential risk from exposure. As can be seen the data indicates that there is a threshold exposure level of approximately 1 mg/m³ years below which there is no increase in risk of developing silicosis.

Figure 5 Cumulative Silicosis Risk from, Ambient Levels and Noncancer Health Effects of Inhaled Crystalline and Amorphous Silica: Health Issue Assessment , US EPA

As can be seen from the data presented in Table 1, there is no additional risk to individuals living in the area around the quarry of developing silicosis, as exposure is below 1 mg/m³ years. AECOM notes that the particulate concentration used from other Winstone quarries is total suspended particulate data, and is likely to be an overestimate of the actual PM₁₀ averages experienced in the area. Also any actual exposure is likely to be considerably less than that used in the risk assessment which is based on the standard exposure of 70 years.
